# In-Service Performance Assessment of a Traditional Timber House Under Real Environmental Conditions Using Ambient Vibration Measurements

## ORIGINAL SCIENTIFIC PAPER

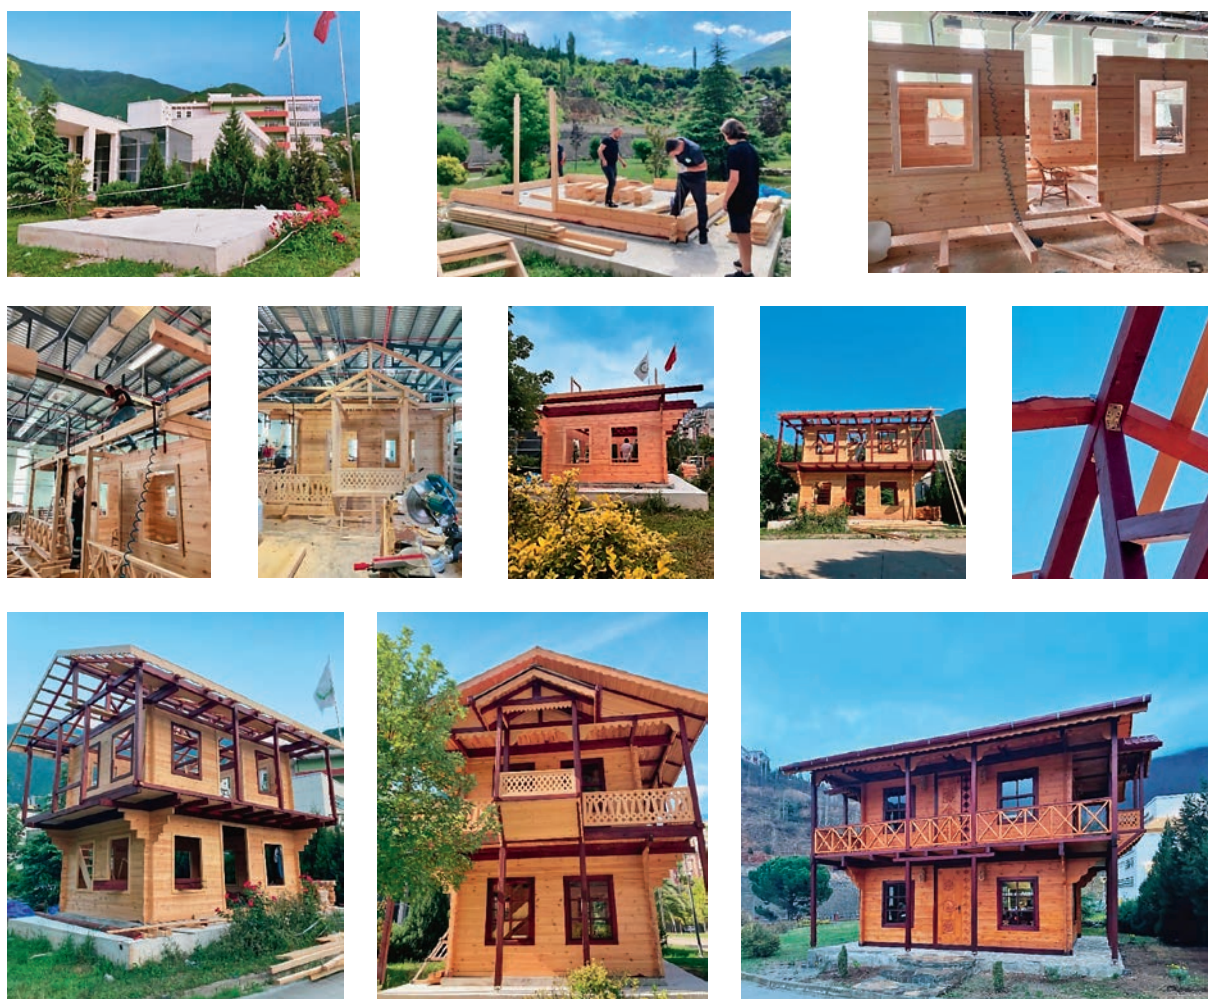
**Figure 1** Some images of construction stages

The construction process of the two-storey traditional timber house is summarized with emphasis on the structural components relevant to the vibration assessment. Some images of construction stages are shown in Figure 1.

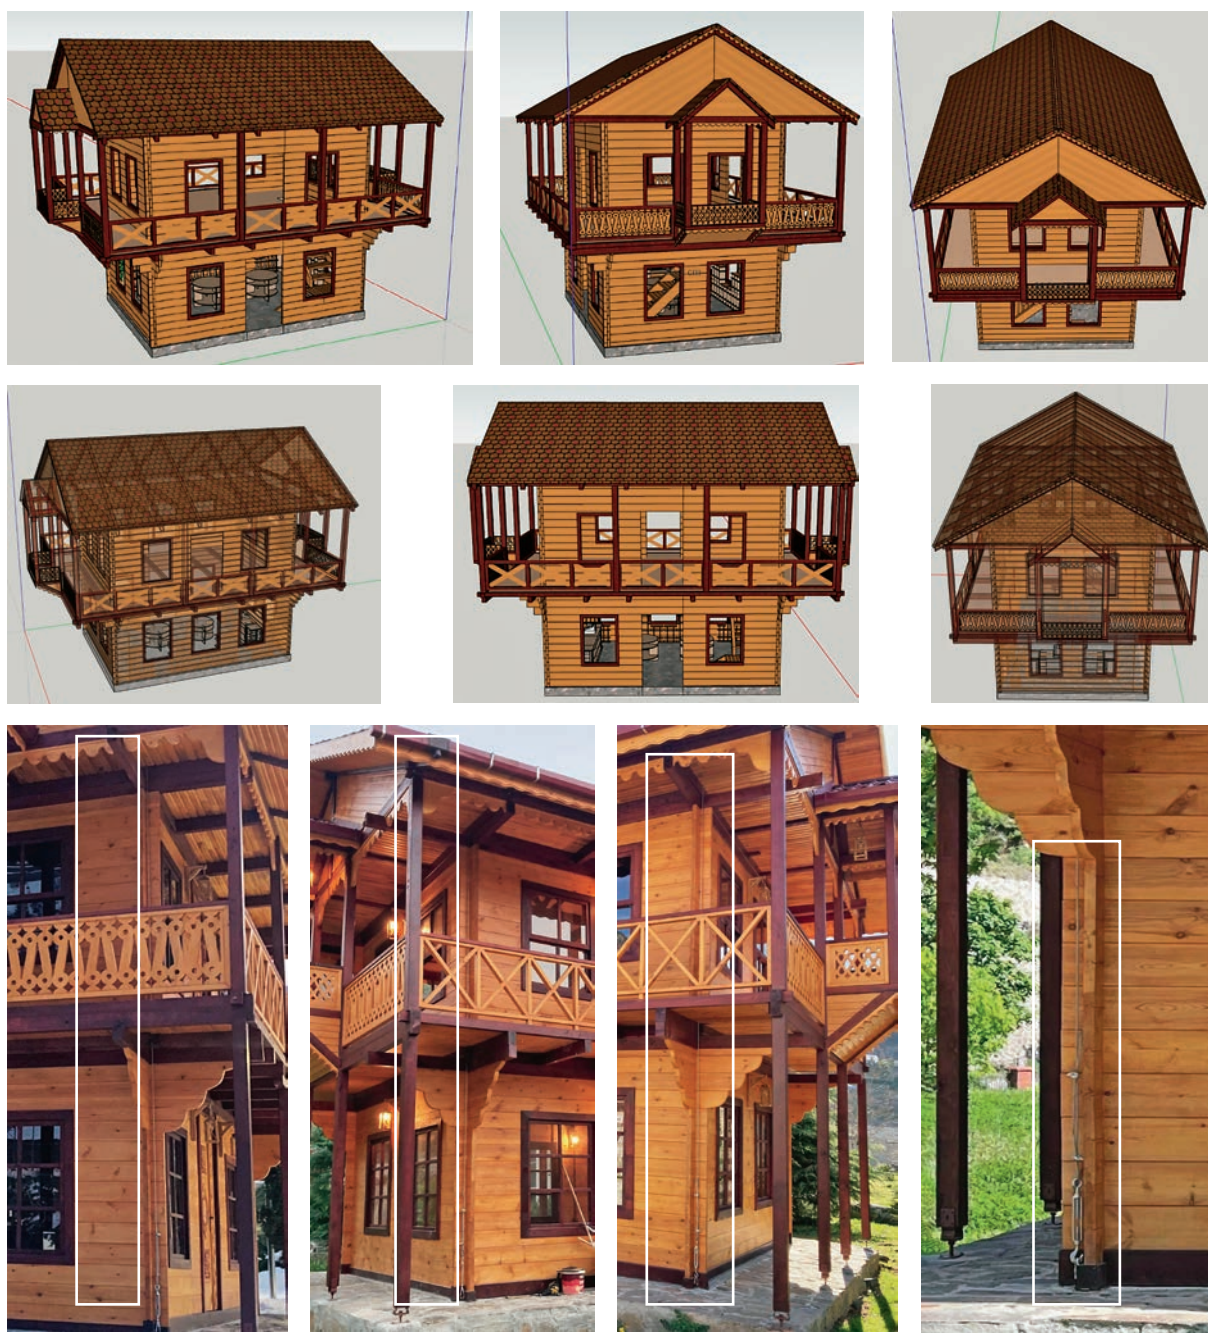
**Figure 2** Some images of 3D views and grooved joints (white rectangular)

In traditional Artvin Şavşat Houses, wooden pieces were joined using a technique with grooved joints and some of 3D images and tension status are shown in Figure 2.

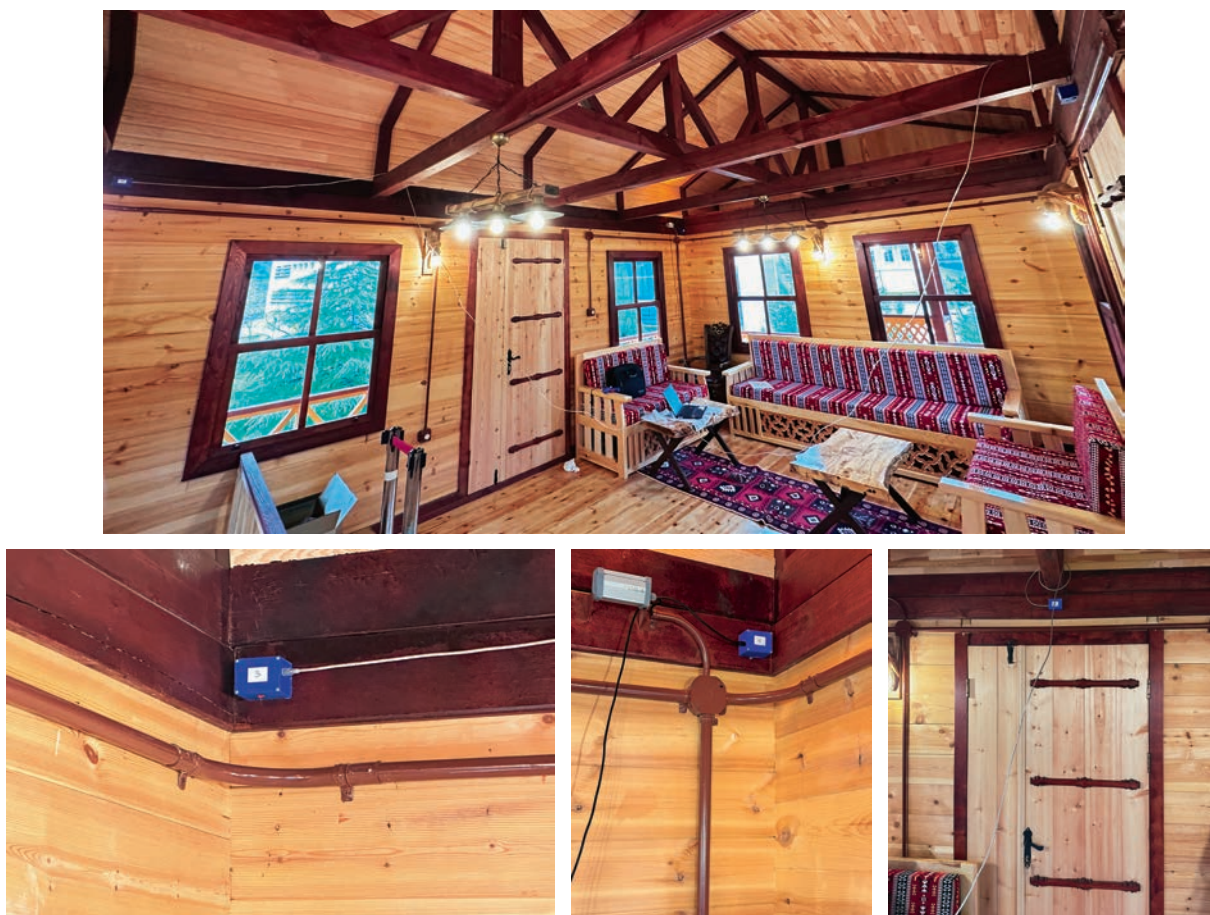
Figure 5 Sample images of vibration measurement setups (CEVS)

In the first measurement setup, 3 CEVS systems were placed in different corners on the 2<sup>nd</sup> floor. In these tests, the timber house was in the normally tensioned state. In the second measurement setup, the timber house was in the tensionless state, and in the third measurement setup, the timber house was in the fully tensioned state. In the tests, different vibration measurements were made according to the tension status of the traditional timber house.

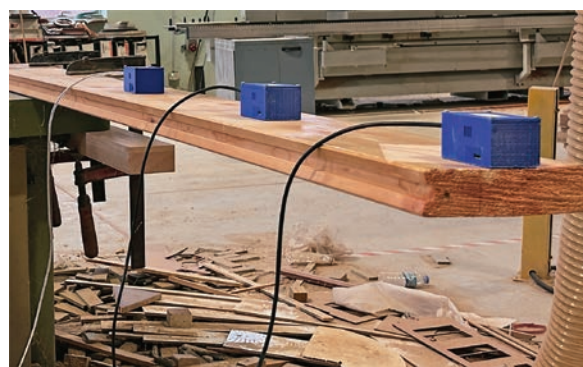
**Figure 10** Some images of cantilever vibration measurement setup

Some of the materials used in the timber structure were tested in a laboratory environment. Vibration measurements were collected with the CEVS vibration measurement system on a structure consisting of wooden elements and a cantilever beam, and information about the material properties of the structure was

obtained. The measurement devices established are given in Figures 10-11.

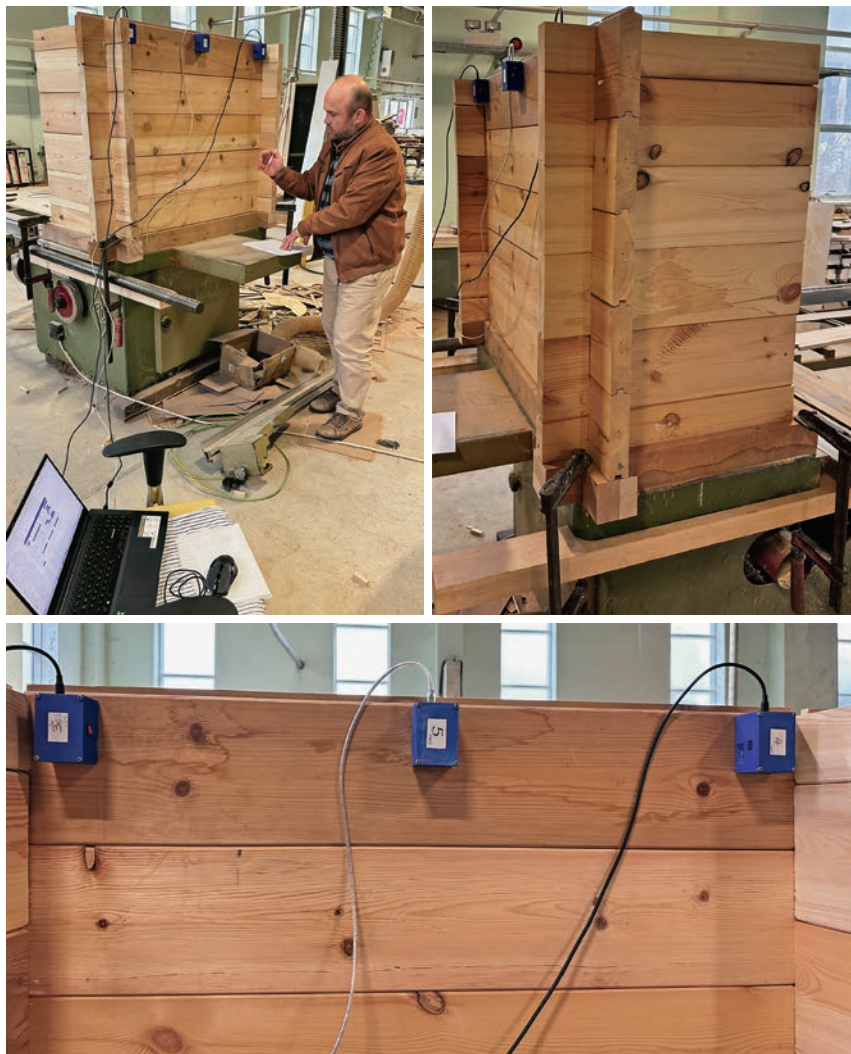
**Figure 11** Sample images of individual element vibration measurement setup
